**COMPLIANCE STATUS REPORT**

Source Name <u>Ash Grove Cement Co.</u>	Responsible Person, Title <u>Gerry Brown, E H &amp; S Mgr</u>
Location <u>3801 E. Marginal Wy S</u> <u>Seattle, WA 98134</u> <u>206-623-5596</u>

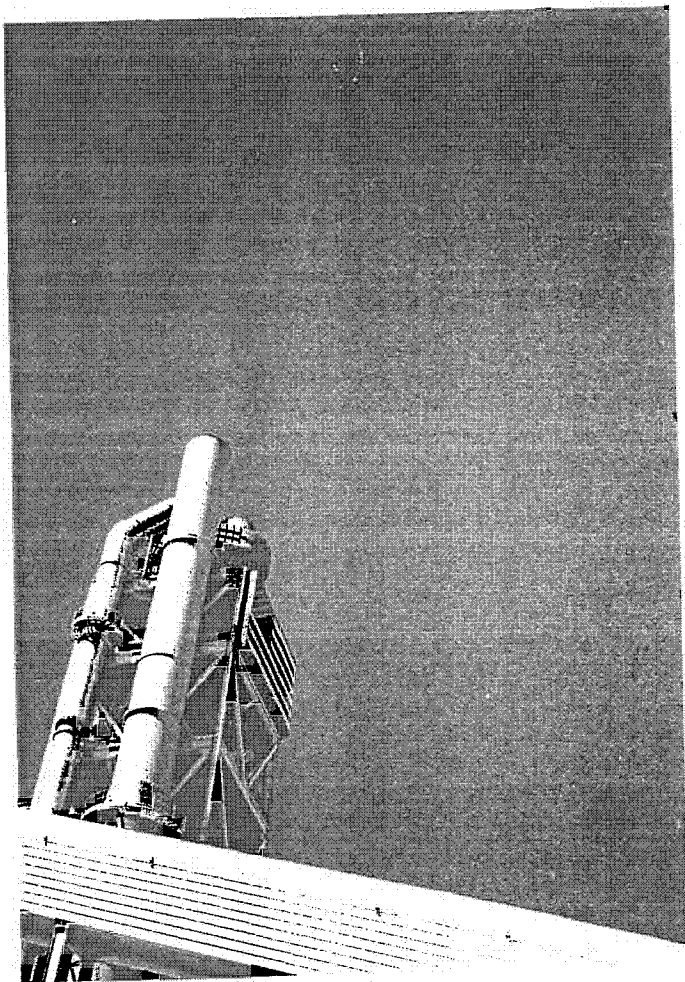
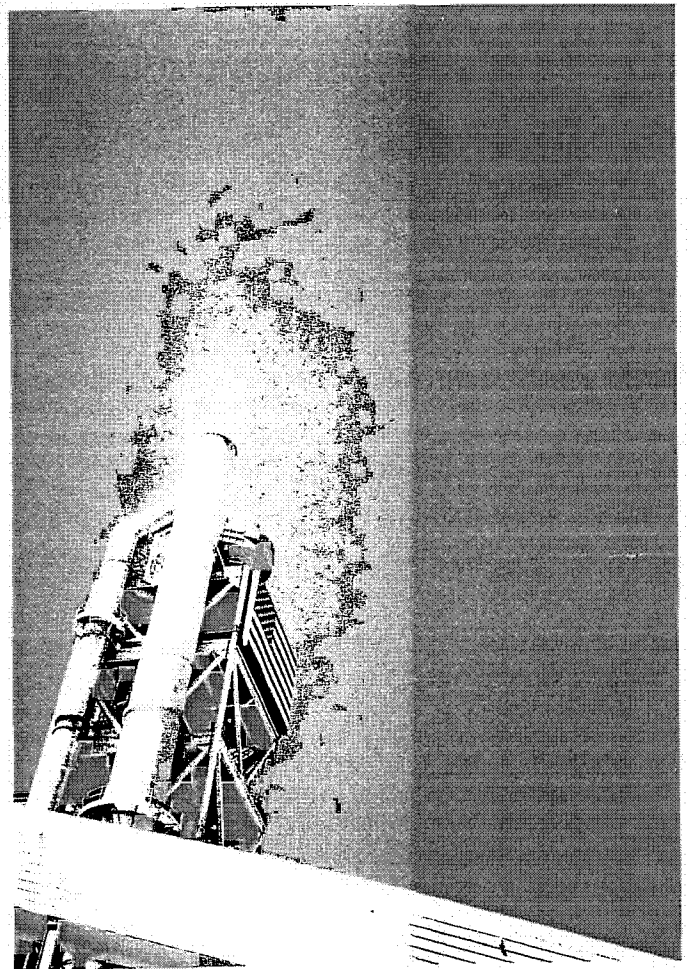
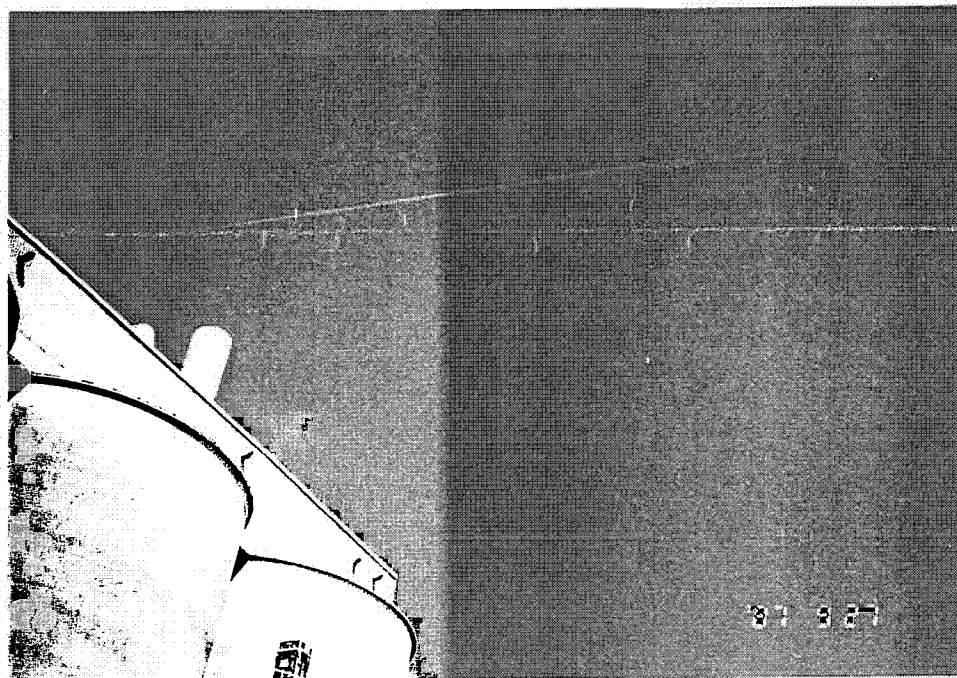
Continuous emissions of particulate from  
both the main stack and from side vent on  
clinker silos. (see attached photos). (Reg I Sect. 9.20)  
Heavy fallout accumulation (up to ~1/3 inch)  
which was clinker like in appearance & by  
gritty texture on about 25 cars parked  
at Bays A+B at Terminal 106. (Reg I Sect 9.11)

Dust collector 474.141: This D/C located on top of the clinker storage silos (six pack) was shut down shortly after 3:00 p.m. on July 20 upon confirmation of it dusting. It remained off line until the following day. On July 21, Mr. Jim Langley and Todd McNitt inspected the both the dirty and clean side of 474.141 dust and did not find any obvious problems. The traveler and blow back fan were operating without problems. There was some residual dust in the clean side and the bags were pretty caked up on the dirty side. They shook down and cleaned the bags, closed the D/C up and ran in local. There was an initial puff of dust when it first started, but cleared up quickly. They observed the vent for approx. 20 minutes and did not see any more dusting.

Visible emissions from the main stack: Coinciding with your report, main baghouse compartment 11 was being put on line after several days of extensive maintenance. The act of placing the compartment on line is believed to have caused a spike but there was no opacity violation recorded by the COM monitor at that time during this day.

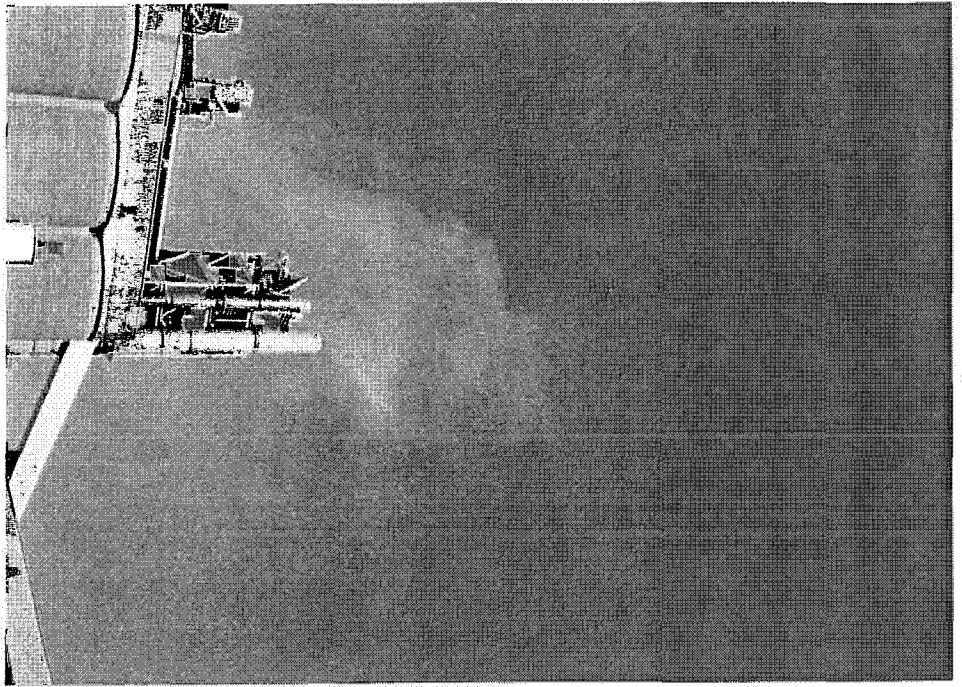
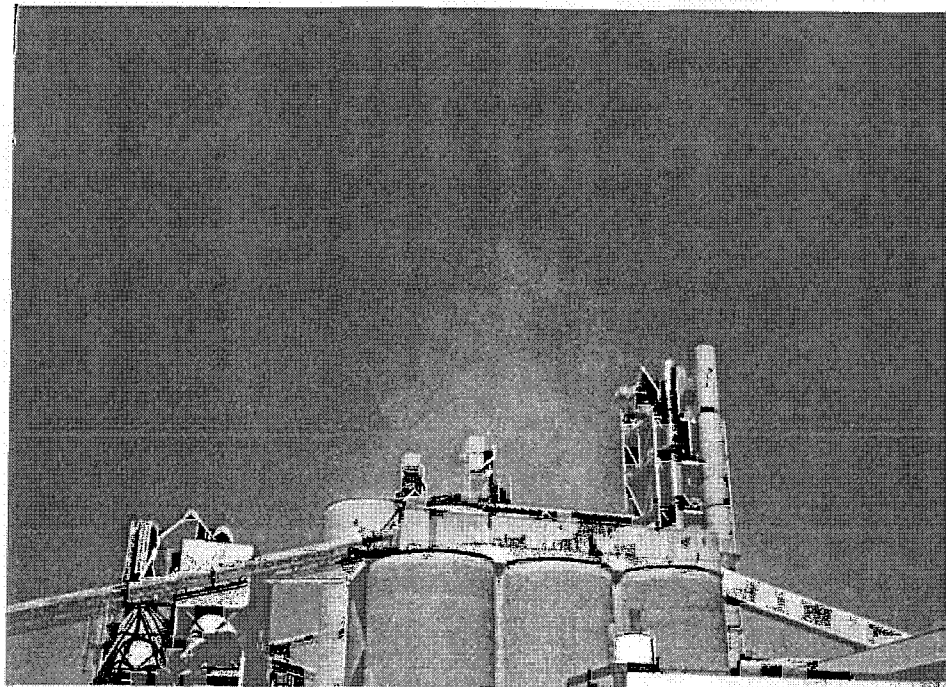
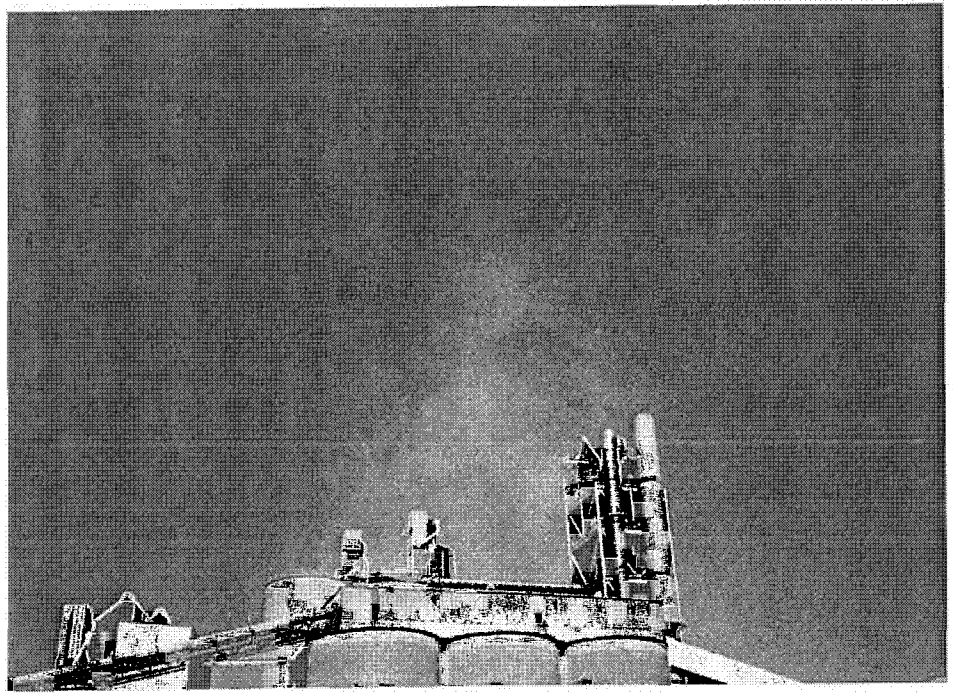
Visible emissions observed over clinker  
storage silos on 8/14/98 at 1:57 p.m.  
Please report the cause of the problem  
and corrective actions taken.

The emission was caused by a faulty high-level bin indicator which lead to over filling the hydrated lime tank. The bin high level switch has been repaired.

As you are aware, we have been in the process of installing load cells on the lime tank for determining volume. Electrical wiring and structural modifications to X-bracing on the tank have been completed. The project will be completed with the placement of the load cells. Following testing, the system should be completely functional within 2-3 weeks.
